### **Project 1 Information:**

Project Name: Fresh Coast Protection Partnership – New Testament Church Address/City/State/Zip: 10201 W Bradley Rd, Milwaukee, WI 53224

## Projects 2 & 3 Information:

Project Name: Lake and Cook County Forest Preserves Felled Timber Grade Controls Address/City/State/Zip: Elm Road Woods (Lincolnshire, IL) and Carl R. Hansen Woods (Elgin, IL)

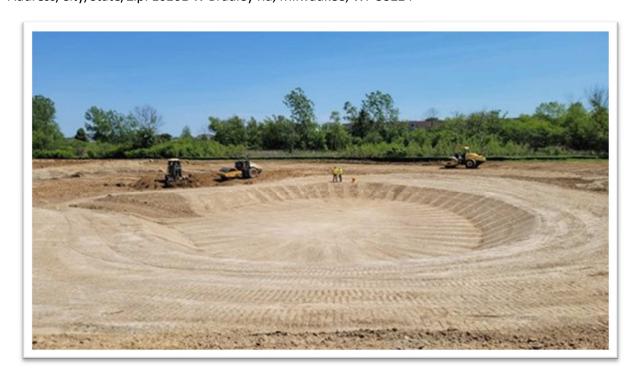
**Project Description (Be sure to include cost information, photos, and a detailed description of the work performed by the Vendor applicant):** Project includes design and construction of newly constructed stormwater wetlands (CSW) that detain stormwater and promote evapotranspiration to reduce risk of combined sewer overflows and basement backups, toward achieving the MMSD's WPDES goal to capture 50 million gallons of stormwater and its 2035 Vision and Regional Green Infrastructure Plan to install GI to capture 740 million gallons of storm water.

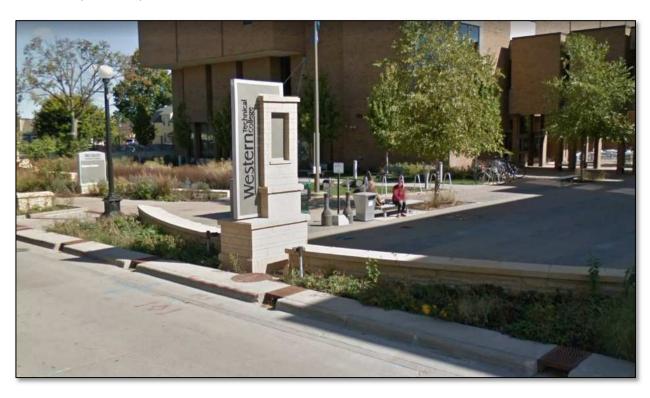
**Project Description (Be sure to include cost information, photos, and a detailed description of the work performed by the Vendor applicant):** Campus-wide redevelopment for a multi-million-dollar program that entails a complete overhaul of the pedestrian and vehicular traffic movement, parking, storm water management, lighting, and franchise utilities. Project goal is to create a pedestrian friendly environment that improves the student experience and increases enrollment. All components of the project comply with the LEED certification program. Aqua Vitae designed bio-infiltration street planters, rain gardens, and underground storage chambers to capture street and parking lot runoff, promote infiltration, and reduce total suspended solids (TSS). Engineered soils and native vegetation were significant components of the bio-engineering design. The results were no-net-increase in runoff from the 2-year and 10-year storm events and full credit to offset the Storm Water Utility (SUT) fees.

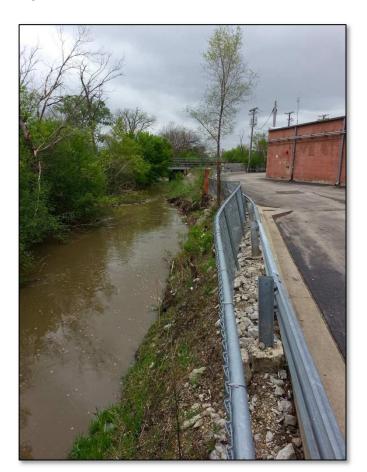
**Project Description (Be sure to include cost information, photos, and a detailed description of the work performed by the Vendor applicant):** Emergency stream bank stabilization using bio-engineering techniques to protect infrastructure. The design includes rock vane in-stream structures and native vegetation to stabilize the bank from surface sliding and toe scour that could potentially undermine the delivery driveway above which is frequently used by tractor-trailer delivery trucks. Aqua Vitae worked collaboratively with an ecological restoration firm for the design-build and provided construction direction to the contractor for the proper installation of the rock vanes and riprap. Aqua Vitae has been conducting routine inspections since construction to verify the bank integrity and document stream evolution.
